Sans Souci Court

501 W. Whiting Avenue

1923

Status: Local Landmark

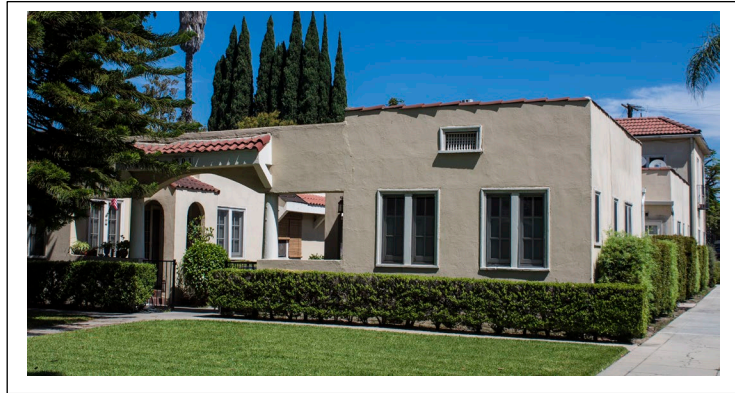
A Spanish Colonial architecture was used for this bungalow court, one of the few constructed in Fullerton in the 1920s. Single-story buildings on the east and west sides of a small central courtyard flank a two-story structure at the rear of the property. Distinguishing features include a decorative fascia supported by round columns that connects the two single story buildings; the small, enclosed porches for the units; and the use of shed roofs with tile over openings.

When the bungalow court opened in 1923, it originally contained six apartments within a “H”-shaped, two-story building at the rear of the property. The rear portion of the building closest to Chapman Avenue, which contained a five-stall garage and two units on the second floor, was demolished when Chapman Avenue was widened in 1967. At some point prior to 1990, the two units on the top of the remaining portion of the second-story building were converted into one larger unit with three bedrooms. The property currently consists of seven apartments.

In 2021, the owner removed the stucco wall that spanned the front entry, along with its decorative, tiled-covered shed roof, because it showed signs of deterioration and a danger to residents. There are no plans to replace this original feature of the bungalow court.
